**HISTORIC RESOURCES INVENTORY**  
**BUILDING AND STRUCTURES**  
 HIST-6 NEW 5 77

1. BUILDING NAME (Common) <i>(Historic)</i>		Seward, Moses, House	
2. TOWN CITY	VILLAGE	COUNTY	
Durham		Middlesex	
3. STREET AND NUMBER (and or location)			
New Haven Road, west side			
4. OWNER(S)			
Otte, Carl & Helena <span style="float: right;"><input type="checkbox"/> Public <input checked="" type="checkbox"/> Private</span>			
5. USE (Present)		<i>(Historic)</i>	
Residence		Residence	
6. ACCESSIBILITY TO PUBLIC:	EXTERIOR VISIBLE FROM PUBLIC ROAD	INTERIOR ACCESSIBLE	IF YES, EXPLAIN
<input checked="" type="checkbox"/> Yes <input type="checkbox"/> No	<input type="checkbox"/> Yes <input checked="" type="checkbox"/> No

7. STYLE OF BUILDING		DATE OF CONSTRUCTION	
Center Chimney Colonial		ca. 1760	
8. MATERIAL(S) <i>(Indicate use or location when appropriate)</i>			
<input checked="" type="checkbox"/> Clapboard	<input type="checkbox"/> Asbestos Siding	<input type="checkbox"/> Brick	<input type="checkbox"/> Other <i>(Specify)</i>
<input type="checkbox"/> Wood Shingle	<input type="checkbox"/> Asphalt Siding	<input type="checkbox"/> Fieldstone	
<input type="checkbox"/> Board & Batten	<input type="checkb

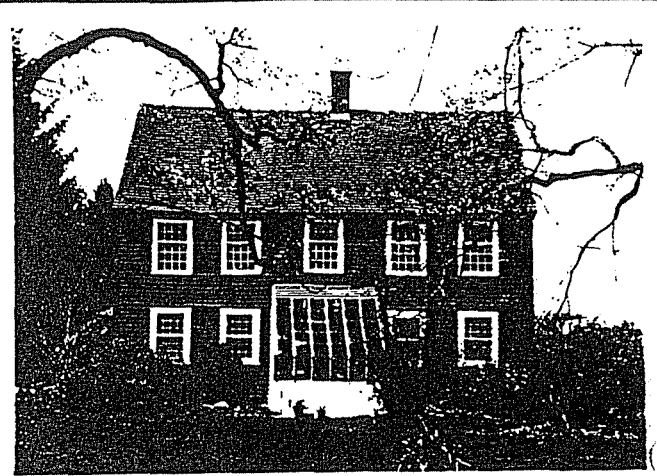
COMPILED BY PHOTO

The original eight-over-twelve sash remain and the original center chimney has been replaced by a small brick stack. Additions include a small modern greenhouse to the facade which protects the main entry and a single story shed-roofed ell projecting from the rear. A small gable-roofed garage is sited to the north of the house.

Constructed about 1760, this well-preserved five-bay, 2½ story, Colonial-period house faces east onto New Haven Road. Resting on a sandstone foundation, the post-and-beam frame is capped by an asphalt-shingled, ridge-to-street gable roof.

PHOTOGRAPHER	DATE
Alex Parades	5/84
VIEW	NEGATIVE ON FILE
W	14:16
NAME	DATE
E.R. Hart	3/84
ORGANIZATION	
Greater Middletown Preservation Trust	
ADDRESS	
27 Washington St., Middletown, Conn. 06457
