**HISTORIC RESOURCES INVENTORY  
BUILDING AND STRUCTURES**

IDENTIFICATION	1. BUILDING NAME (Common) <span style="float: right;">(Historic)</span>		Guida, John, House	
	2. TOWN/CITY	VILLAGE	COUNTY	
	Durham		Middlesex

3. STREET AND NUMBER (and or location)			
	Maiden Lane, south side, corner of Main Street			
	4. OWNER(S)			
	John and Catherine Guida		<input type="checkbox"/> Public <input checked="" type="checkbox"/> Private	
DESCRIPTION	5. USE (Present)		(Historic)	
	Residence		Residence/shoe shop

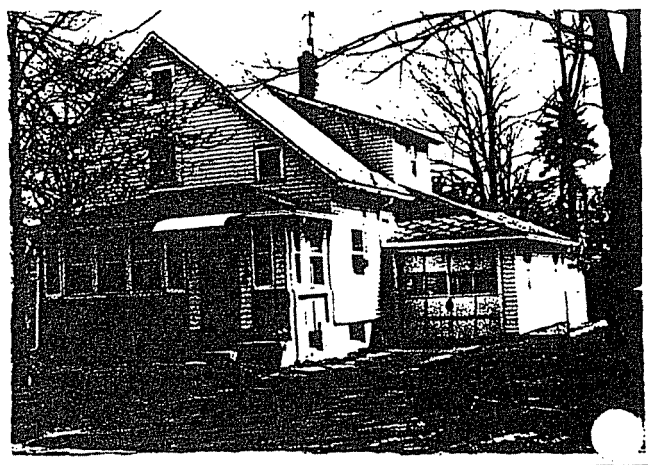
PHOTO	PHOTOGRAPHER	DATE
	Alex Parades	5/84
COMPILED BY	VIEW	NEGATIVE ON FILE
	Southeast	11:28A
COMPILED BY	NAME	DATE
	P. D. Hall	5/5/84
	ORGANIZATION	
Greater Middletown Preservation Trust		
ADDRESS		
27 Washington Street, Middletown, CT 06457

The Guida House is a 3/4 story aluminum-sided structure. Its gable end faces the street. Its left side displays a one-foot overhang. A porch has been added to the north gable end which faces the street. A one-car garage has been added to its southwest corner.
