STATE OF CONNECTICUT
CONNECTICUT HISTORICAL COMMISSION
59 SOUTH PROSPECT STREET, HARTFORD, CONNECTICUT 06106
(203) 566-3005

IDENTIFICATION	1. BUILDING NAME (Common) The John Jackson House		(Historic) Shelly, Russell House	
	2. TOWN CITY Durham		VILLAGE	COUNTY Middlesex
	3. STREET AND NUMBER (and or location) 132 Main Street

STATE OF CONNECTICUT
CONNECTICUT HISTORICAL COMMISSION
59 South Prospect Street, Hartford, Connecticut 06106
HISTORIC RESOURCES INVENTORY FORM
For Buildings and Structures

The John Jackson House
132 Main Street
Durham:

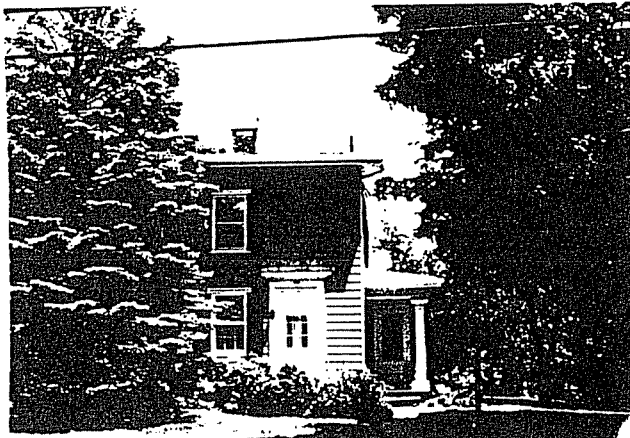
West elevation

The doorframe with fluted pilasters and a full entablature is elaborate. Also a small corner porch is supported by a single Victorian-style pillar.

This structure is a three-bay, flat-hip-roofed, side-hall entry Greek Revival-style residence. Its facade has been somewhat altered, the front entry is placed disproportionately close to the second of the two windows on the first story, and the window above it on the second story has been removed and shingled over. Nevertheless, the facade retains many original features, including a doorframe with fluted pilasters and a full entablature, an original 2 pane over 2 paneled glass and wood door, and 6 X 6 window. The south side has been altered with the construction of a one story hip-roof entry addition which contains its own entry door. This door is sheltered by a small corner porch, the roof of which is supported by a single Victorian-style pillar. The north side has been altered by the construction of a two story shed-roof addition which also possess its own entry. To the rear a one story gable roof addition has been constructed. The whole structure has been sheathed with wooden shingles, replacing original clapboarding. The roof is characterized by a wide overhang which suggests a transition to the Italiante and the possibility that the house once boasted bracketing. (See continuation sheet)
