**HISTORIC RESOURCES INVENTORY  
BUILDING AND STRUCTURES**  
HIST-6 NEW 5 77

<b>IDENTIFICATION</b>	1. BUILDING NAME (Common) <span style="float: right;">(Historic)</span>	
	Francis E. Korn House	Hubbard, Francis House
	2. TOWN CITY Durham	VILLAGE COUNTY Middlesex
	3. STREET AND NUMBER (and or location) 90 Main Street	
	4. OWNER(S) Clara Korn <span style="float: right;"><input type="checkbox"/> Public <input checked="" type="checkbox"/> Private</span>

Hubbard, Francis House  
90 Main Street  
Durham

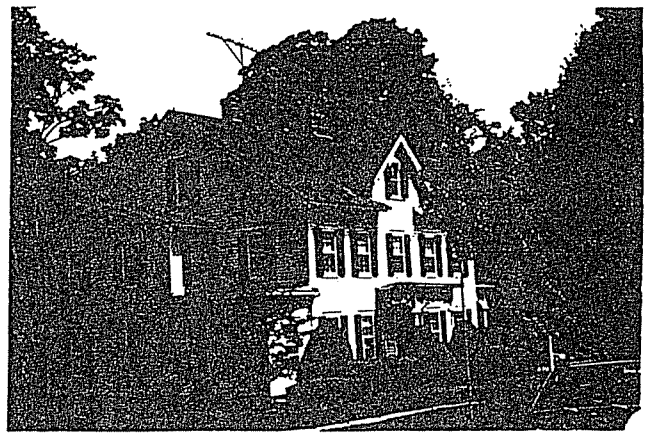
Hip-roofed portico, supported by thin octagonal wooden columns, are joined by spandrels ornamented with sawn-out quatrefoils. The dormer is sheathed with vertical flush boards.

The Hubbard-Francis House is a substantial two and a half story nineteenth-century domestic vernacular structure. It stands on a sandstone block foundation. The front entry is centered on the facade. It is protected by a projecting hip-roofed portico which is supported by thin octagonal wooden columns. The columns are joined by spandrels ornamented with sawn-out quatrefoils. The entry contains is a four panel Italianate door which is original to the house. The main entry is flanked by four symmetrically placed 6X6 windows with shutters. The second story of the facade contains 6X6's arranged in five bays. The facade is surmounted by a gable roofed dormer. It is sheathed with vertical flush boards and contains an arch-top 2X2 window. The roof of this house is characterized by an unusually wide soffit, suggesting that it may originally have been supported by brackets. This would be consistent with other Italianate features of the structure. To the North and South gable ends of the main block stand two symmetrical two story gable roof additions measuring 22X7. Structural evidence suggests that, if not original to the structure, they were added shortly after its erection. To the front of these are two later one story hip roof additions which though similar in shape, preserving the symmetry of the structure, serve different functions. The south side addition is an open entry porch containing the same unusual ornamental features of the main portico. The north side addition is enclosed, and contains two 6X6 windows. (Continuation)

PHOTOGRAPHER	DATE
P.D. Hall	6/10/83
VIEW	NEGATIVE ON FILE
N. and W. elevations	III:27
NAME	DATE
P.D. Hall	8/20/83
ORGANIZATION	
Greater Middletown Preservation Trust	
ADDRESS	
27 Washington St., Middletown, CT. 06457
