HISTORIC RESOURCES INVENTORY
BUILDING AND STRUCTURES
 HIST-6 NEW 5 77

1. BUILDING NAME (Common) <i>(Historic)</i>		Crane, Henry, House	
2. TOWN CITY	VILLAGE	COUNTY	
Durham		Middlesex	
3. STREET AND NUMBER (and or location)			
Cherry Lane, north side

THE HENRY CRANE HOUSE, Cherry Lane, Durham

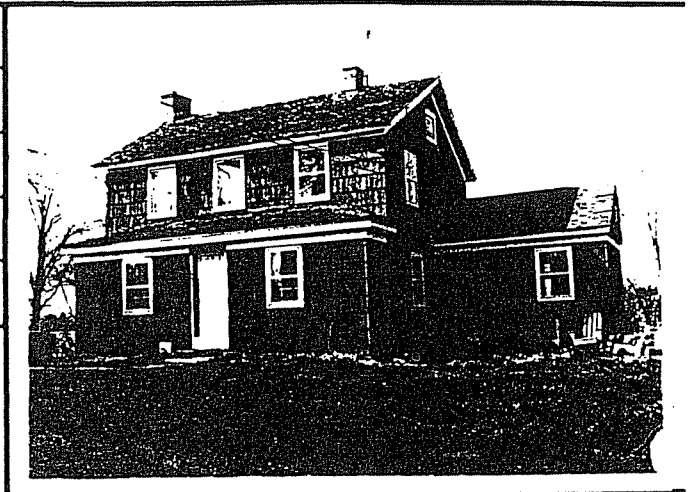
PHOTO	PHOTOGRAPHER	DATE
	Alex Parades	4/84
VIEW	NEGATIVE ON FILE	
	N	10:15
COMPILED BY	NAME	DATE
	E.R. Hart	
	ORGANIZATION	
	Greater Middletown Preservation Trust	
ADDRESS		
27 Washington St., Middletown, Conn. 06457

The 1 story, three-bay, hip-roofed enclosed porch added to the facade in the nineteenth century features a modern doorway flanked by two six-over-six sash. The 1 story, gable-roofed ell which extends from the eastern elevation most likely was added at the same time as the facade addition. The original center chimney has been replaced and a modern exterior chimney has been added to the western elevation. There is a shed-roofed addition to the rear.

Facing south onto Cherry Lane, this Colonial period house was erected by Henry Crane ca. 1785. The 2½ story building topped with a wood-shingled, ridge-to-street gable roof features a center-hall plan with a three-bay facade. Utilizing a post-and-beam framing system, the house is asbestos-sided and rests on a sandstone foundation.
