STATE OF CONNECTICUT
 CONNECTICUT HISTORICAL COMMISSION
 59 SOUTH PROSPECT STREET, HARTFORD, CONNECTICUT 06106
 (203) 566-3005

1. BUILDING NAME (Common) (Historic)		Davis-Brainerd House	
2 TOWN CITY	VILLAGE	COUNTY	
Durham		Middlesex	
3 STREET AND NUMBER (and or location)			
28 Main Street (east side) [Note: 24, 26, 28 Main Street are located on the same lot]			
4 OWNER(S)			
Sweet, Lloyd L. and Stella P.			<input type="checkbox"/> Public <input checked="" type="checkbox"/> Private
5 USE (Present)		(Historic)	
Residence		Residence	
6 ACCESSIBILITY TO PUBLIC:		IF YES EXPLAIN	
<input checked="" type="checkbox"/> Yes <input type="checkbox"/> No		<input type="checkbox"/> Yes <input checked="" type="checkbox"/> No

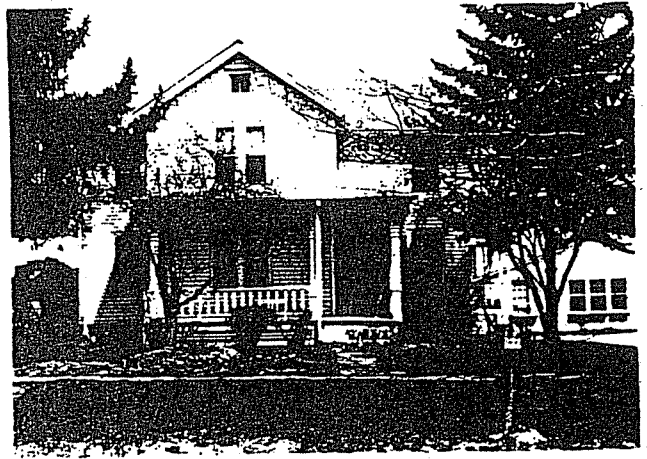
Full-length wrap-around porch to the south side
 Four chamfered posts with sawn brackets.

19 HISTORICAL OR ARCHITECTURAL IMPORTANCE
 Henry Davis built this clapboarded, 2½ story, balloon-framed house about 1885. The asphalt-shingled gable roof is oriented towards the street and the building rests on a sandstone block foundation. The facade includes a full-length wrap-around porch to the south side. It has four square chamfered posts with sawn brackets and a simple stick balustrade with a spandrel of cut work. The unusual facade is marked on the first story by a long central window with two narrow vertical panes; a smaller version of the same window is found on the second story, and in the gable end is a small double vertical-paned window. The entryway is on the south end of the porch and the door is sheltered by the south porch and is located on the facade of the south two-story ridge-to-street addition. There is a two-story north addition, an east addition, and a small shed-roofed porch supported by slender columns to the southeast off the main part of the house.
