**HISTORIC RESOURCES INVENTORY
BUILDING AND STRUCTURES**
HIST-6 NEW 5 77

IDENTIFICATION	1. BUILDING NAME (Common) (Historic)	
	Camp, David, House	
	2 TOWN CITY Durham	VILLAGE Middlesex
	3 STREET AND NUMBER (and or location) 14/16 Main Street (east side)	
	4 OWNER(S) Ackerman, Sr., Austin M. <input type="checkbox"/> Public <input checked="" type="checkbox"/> Private	
DESCRIPTION	5 USE (Present) (Historic) Residence Residence

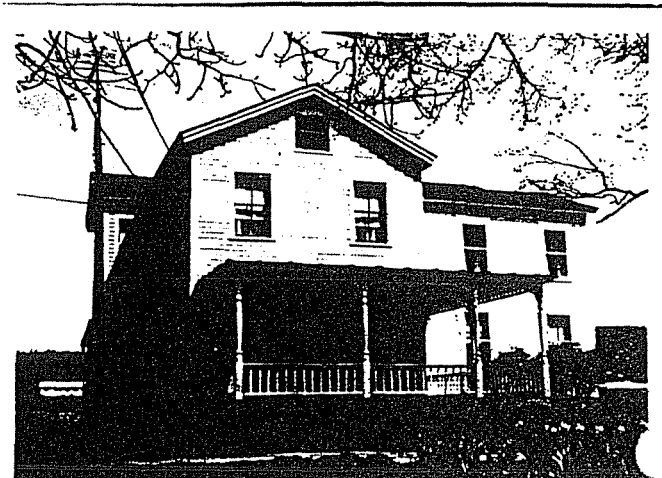
PHOTOGRAPHER	DATE
Alex Parades	4/84
VIEW	NEGATIVE ON FILE
E	11:12
NAME	DATE
I. Heublein	8/3/83
ORGANIZATION	
Greater Middletown Preservation Trust	
ADDRESS	
27 Washington St., Middletown, CT 06457

The 2 bay facade has a wrap-around stickwork porch to the south, which has a shed roof supported by four turned posts. The doorway is located on the west facade of the 2 bay ridge-to-street cross gable south extension. Additions to the house include a 2 story, 2 bay, gable-roofed extension on the northeast, two east additions and a southeast shed-roofed porch/entry.

In 1861 David Camp built a 2½ story, post-and-beam-framed house. The building has an asphalt-shingled gable-to-street roof and rests on a mortared sandstone block foundation.
