BUILDING AND STRUCTURES

STATE OF CONNECTICUT
CONNECTICUT HISTORICAL COMMISSION
 59 SOUTH PROSPECT STREET, HARTFORD, CONNECTICUT 06106
 (203) 566-3005

1. BUILDING NAME (Common) <i>(Historic)</i>		Hubbard, Reuben, House	
2. TOWN CITY	VILLAGE	COUNTY	
Durham		Middlesex	
3. STREET AND NUMBER (and or location)			
8 Main Street (East side)

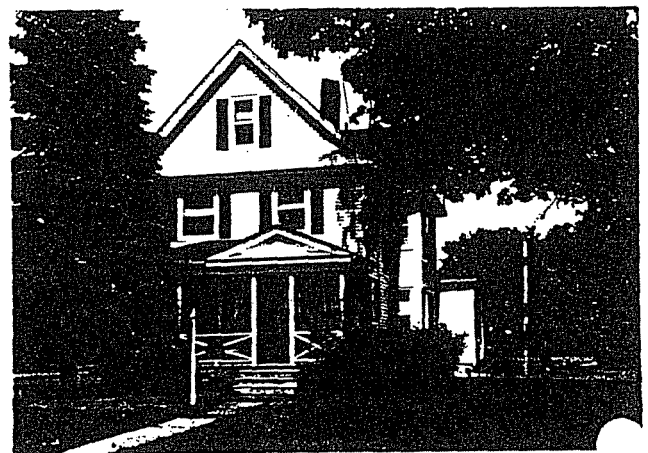
PHOTO

There is a full length hip-roofed porch with a pediment at the south end, across the facade. Five stick posts support the roof and a stick balustrade trims the porch. On the first story are two south doors, to accommodate this two-family house, and a north side window. Two windows complete the second story and a small vertical window is located in the fully-pedimented gable. The gable ends, which swoop outward to form a large overhang appearing on the facade gable and the two north and south story additions, are unusual features.

PHOTOGRAPHER	DATE
P.D. Hall	Summer 1983
VIEW	NEGATIVE ON FILE
West view	2:25a
NAME	DATE
I. Heublein	8/3/83
ORGANIZATION	
Greater Middletown Preservation Trust	
ADDRESS	
27 Washington St., Middletown, Conn. 06457
