**HISTORIC RESOURCES INVENTORY  
BUILDING AND STRUCTURES**

STATE OF CONNECTICUT  
CONNECTICUT HISTORICAL COMMISSION  
59 SOUTH PROSPECT STREET, HARTFORD, CONNECTICUT 06106  
(203) 566-3005

1. BUILDING NAME (Common) <i>(Historic)</i>		Camp, Elias, House	
2. TOWN CITY	VILLAGE	COUNTY	
Durham	Center	Middlesex	
3. STREET AND NUMBER (and or location) Maple Avenue, east side

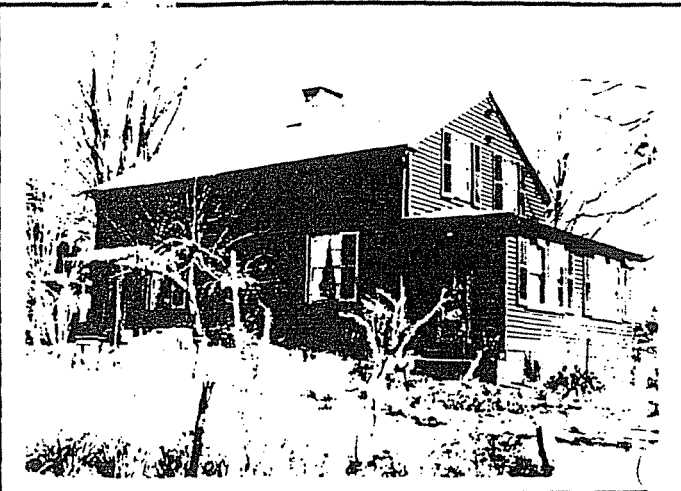
VIEW	NEGATIVE ON FILE
NE	10:5

17 OTHER NOTABLE FEATURES OF BUILDING OR SITE (DIPLOMA AND DETAILS)  
 Eyebrow windows set under the eaves on the north and south elevations are characteristic of the Greek Revival style. A single story ell has been added to the rear and a shed-roofed portico supported by two narrow cylindrical columns enhances a south-east entranceway. The main block sash feature lowered shutters.

This 1½ story, nineteenth-century Cape-style building was constructed ca. 1840 by Elias Camp. The facade features a gable-to-street, asphalt-shingled roof and a single story, four-bay, hip-roofed enclosed porch. The post-and-beam frame is clapboarded and rests on a brownstone foundation.  
 Elias Camp (1794-1873), son of Luke and Grace Camp, built this house ca. 1840 on land he purchased from Daniel Bates and Parsons Coe. Married to Mary Bennett, Camp made his living as a shoemaker and in 1817 took the oath of a freeman. In 1855 Elias sold the property to his son, Noyes Frederick Camp (1833-1904). A bachelor all his life, Noyes Camp resided here until his death in 1904.  
 Significant for its association with the Camp Family, the Elias Camp House is an integral part of Durham's Historic Center.
