HISTORIC RESOURCES INVENTORY
BUILDING AND STRUCTURES
 HIST-6 NEW 5 77

IDENTIFICATION	1. BUILDING NAME (Common) _____ (Historic) Parsons, Ithamar, House	
	2. TOWN CITY Durham	COUNTY Middlesex
	3. STREET AND NUMBER (and or location) Middlefield Road, east side	
	4. OWNER(S) Willet, Leo & Dorothy <input type="checkbox"/> Public <input checked="" type="checkbox"/> Private	
	5. USE (Present) _____ (Historic) Residence

ITHAMAR PARSONS HOUSE, Durham

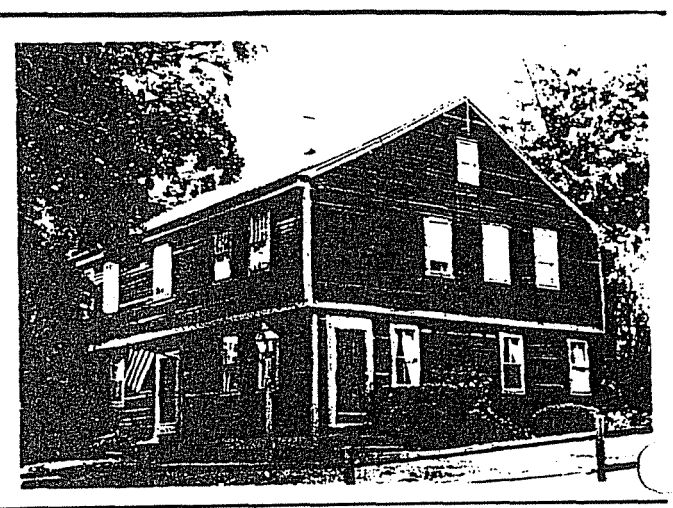
PHOTO	PHOTOGRAPHER P. D. Hall	DATE 6/83
	VIEW Northeast	NEGATIVE ON FILE 5:24
COMPILED BY	NAME E. R. Hart	DATE 5/84
	ORGANIZATION Greater Middletown Preservation Trust	
	ADDRESS 27 Washington Street, Middletown, CT 06457

The most prominent original feature is the large overhang between the first and second floors, which could possibly be a framed overhang.

The elaborate seven-panelled facade door, probably a later addition, is topped by a six-paned overlight. The south elevation displays a similar panelled funeral door. A number of the original twelve-over-twelve sash remain. Other windows exhibit modern two-over-two sash. Two single-story, shed-roofed eels project from the rear elevation. The original chimney has been replaced from the second floor up. Interior features include the original fireplaces, wide floor boards, and encased beams. The large brownstone kitchen fireplace retains its beehive oven, although it has been panelled over. An interesting feature about the large rear fireplace is the initials ISP carved upside down (CONT'D)

One of Durham's most prominent colonial-period buildings is this 2½ story, five-bay, center-chimney structure built in 1733/34 by Ithamar Parsons. Topped by a ridge-to-street, asphalt-shingled gable roof, the clapboarded post-and-beam frame rests on a brownstone foundation. Inscribed in the northwest cornerstone are the dates "1734" and "A.P. 1800."
