**HISTORIC RESOURCES INVENTORY**  
**BUILDING AND STRUCTURES**  
 HIST-6 NEW 5 77

| IDENTIFICATION | 1. BUILDING NAME (Common) <span style="float: right;">(Historic)</span> | | Prout, Benjamin, House | |
| | Saw Mill Road, west side | | | |

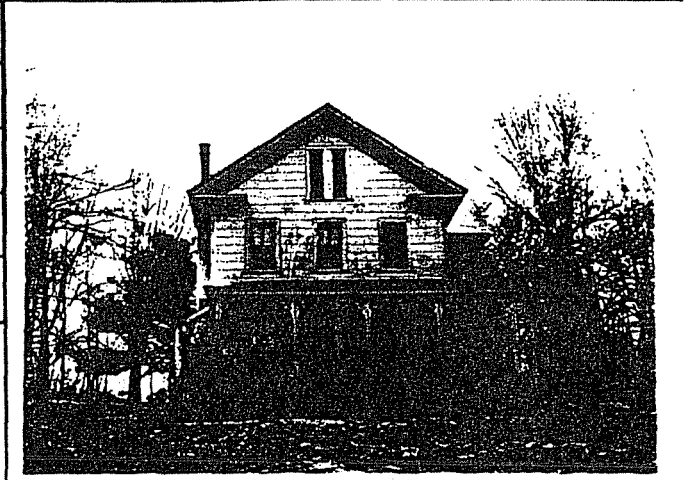
| | West | 14:8 |

Reminiscent of the earlier Greek Revival-style farmhouse, the 3-bay side-hall-plan facade features broad overhanging eaves and large cornice returns. The gable displays a set of long vertical paired windows. Highlighting the facade is an elaborate Queen Anne-style wraparound, balustraded veranda with delicately carved posts, scroll-saw brackets, a decorative frieze, and lattice work. The north elevation exhibits a 2 1/2 story, single-bay crossgable. A single-story, 3-sided bay extends from the south elevation and the original two-over-two sash are featured throughout.

Oriented gable-to-street, this 2 1/2 story, late nineteenth-century house was built in 1896 by Benjamin Prout. Supported by a brick foundation, the asbestos-sided balloon frame is capped by an asphalt-shingled roof.
