**HISTORIC RESOURCES INVENTORY  
BUILDING AND STRUCTURES**

IDENTIFICATION	1. BUILDING NAME (Common) <span style="float: right;">(Historic)</span>	
	Page, Henry, House	
	2. TOWN/CITY	VILLAGE COUNTY
	Durham	Middlesex

3. STREET AND NUMBER (and or location)	
Tri-Mountain Road, east side		
DESCRIPTION	4. OWNER(S)	
	Miller, Harold and Elaine <span style="float: right;"><input type="checkbox"/> Public <input checked="" type="checkbox"/> Private</span>

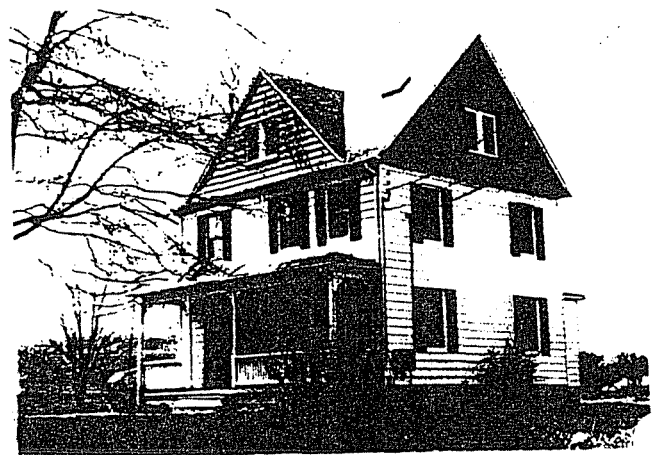
PHOTOGRAPHER		DATE	
Alex Parades		5/84	
VIEW	NEGATIVE ON FILE		
SE	13:20		
NAME		DATE	
E.R. Hart		12/83	
ORGANIZATION			
Greater Middletown Preservation Trust			
ADDRESS			
27 Washington St., Middletown, Conn. 06457

The three-bay facade is highlighted by a balustraded veranda supported on lathe-turned columns and exhibiting scroll-sawn brackets. The veranda roof is interrupted by a decorative pediment above the main entry-way. Hidden from view, the facade doorway is located in a recessed entry alcove. The facade also features a large gable-to-street dormer with paired center windows. Both the north and south gable ends feature an overhang and a similar set of paired windows. The eastern ell displays a full-length hip-roofed porch.

Henry Page built this simple 2½ story, Queen Anne-style house in 1885. Resting on a brick foundation, the aluminum-sided balloon frame is capped by an asphalt-shingled gable roof.
