**HISTORIC RESOURCES INVENTORY**  
**BUILDING AND STRUCTURES**  
 HIST-6 NEW 5 77

IDENTIFICATION	1. BUILDING NAME (Common) <span style="float: right;">(Historic)</span>	
	Wadsworth, Col. James <span style="float: right;">Wadsworth, Col. James, House</span>

THE COL. JAMES WADSWORTH HOUSE, Higganum Road & Madison Road, Durham

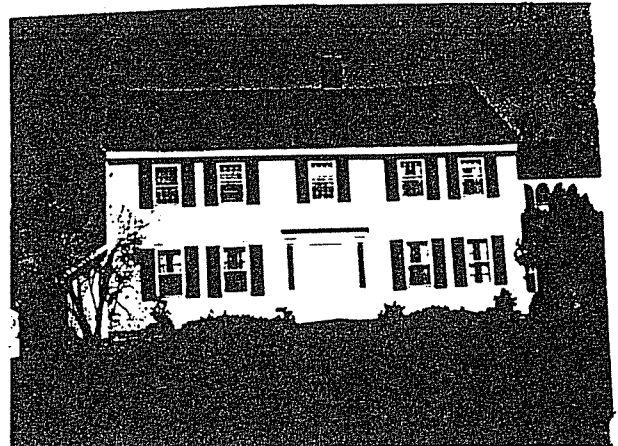
The 5 bay facade is punctuated by a central Greek Revival doorway flanked by two plain pilasters having moulded capitals but no bases, and two three-vertical-pane sidelights. Topping the entry is a plain, thin architrave with a horizontal band of dentil moulding directly below the projecting crown-moulded cornice. Two six-over-six windows with a thin, projecting cornice are found on either side of the door, and five eight-over-two windows with plain frames are located immediately below the eave. Identical dentil moulding, found on the doorway, is repeated under the facade eave. The three additions include a single-story shed-roofed northeast corner addition, a 2 story gable-roofed balloon-framed south addition, and attached to this south addition is an east porch.

The Col. James Wadsworth House, built in 1708, is a clapboarded, 2½ story, Colonial-period building which rests on a sandstone foundation. The post-and-beam frame is covered by a wood-shingled gable roof, ridge-to-Madison Road, and a small off-center east side chimney.
