IDENTIFICATION	1. BUILDING NAME (Common) <span style="float: right;">(Historic)</span>	
	Allen Tucker House <span style="float: right;">Walkley, Jonathan House</span>

2. TOWN CITY	VILLAGE
	Durham	Middlesex
	3. STREET AND NUMBER (and or location)	
	98 Main Street	
	4. OWNER(S)	
	Allen & Ella Tucker <span style="float: right;"><input type="checkbox"/> Public <input checked="" type="checkbox"/> Private</span>

HISTORIC RESOURCES INVENTORY FORM

Item number: 19 Date: 9/23/83 Jonathan Walkley House

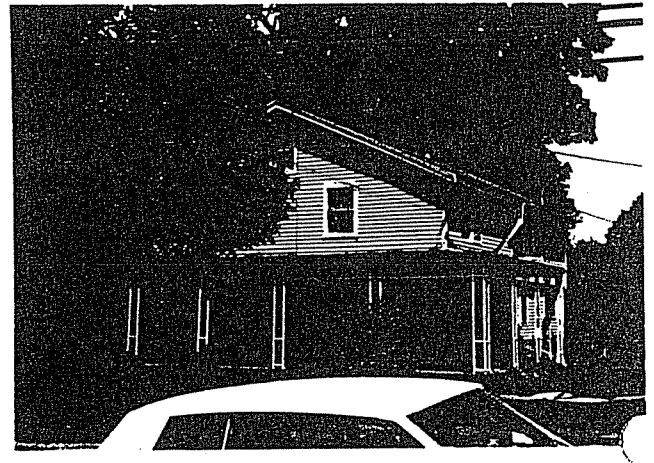
III: 6

This Federal style residence stands with its gable end facing the street. Its facade is fronted by a hip-roofed porch which covers the west, north, and south sides of the main block. The porch is supported by ornamental posts dating from the late nineteenth century. These consist of thin plain piece of milled lumber, doubled and joined by pieces of cast iron molded in botanical patterns. The main entry is centered on the facade and is flanked windows, two 2X2s on the left and one 2X2 to the right. The fenestration in the rest of the main block consists of irregularly grouped 2X2s. To the rear of the main block is a 2 1/2 story gable roofed addition which follows the lines of the main structure. It stands on a poured concrete foundation and dates from the twentieth century. The house was severely damaged by fire in the late 1930s, at which time major alterations were made to the structure. These included changes in fenestration and in interior room arrangements. This house has been historically associated with the adjacent shoe shop at 96 Main Street. It was apparently built by Jonathan Walkley, a cooper, between 1773, when he purchased 42 rods of land from Job Camp, and 1778, when he sold the property "with a dwelling house and cooper's shop" to Beriah Chittenden. Chittenden sold the property in 1784 to Phineas Squire, who sold it to Timothy Shattuck in 1786. Shattuck was a poor businessman. (see continuation)

West elevation
